the **play** inspection company

Annual Inspection

Creech St Michael MUGA

Inspection Ref: 1990886

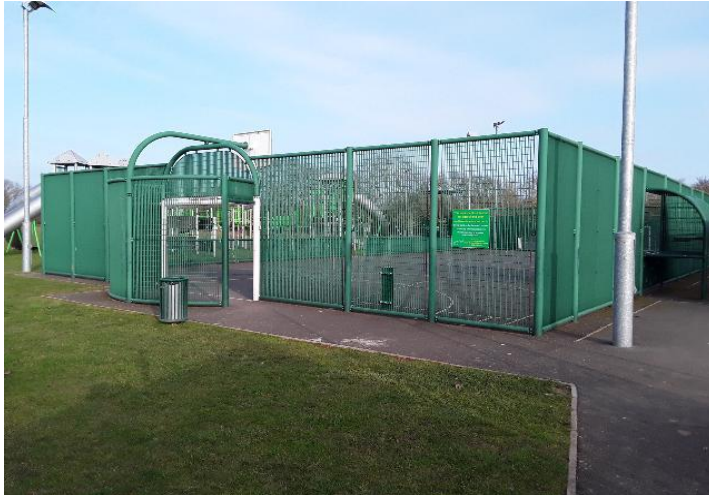
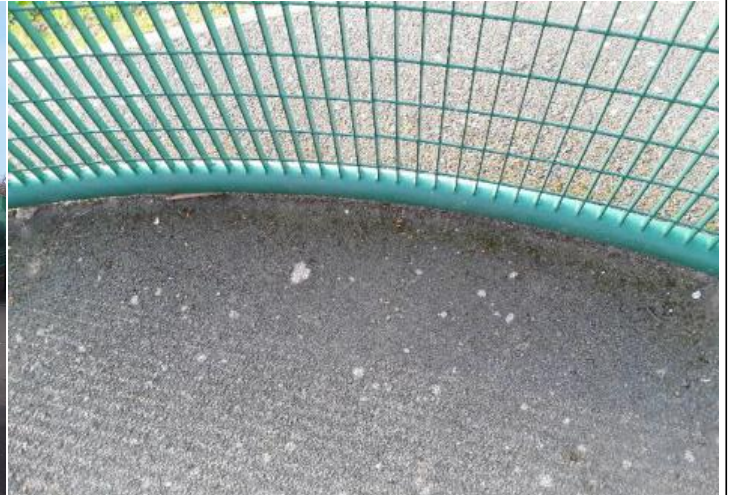
8 - Low Risk (Finding 1)

Finding: There is algae, silt or moss growth on the surface resulting in slippery conditions

Action: Clean and treat appropriately

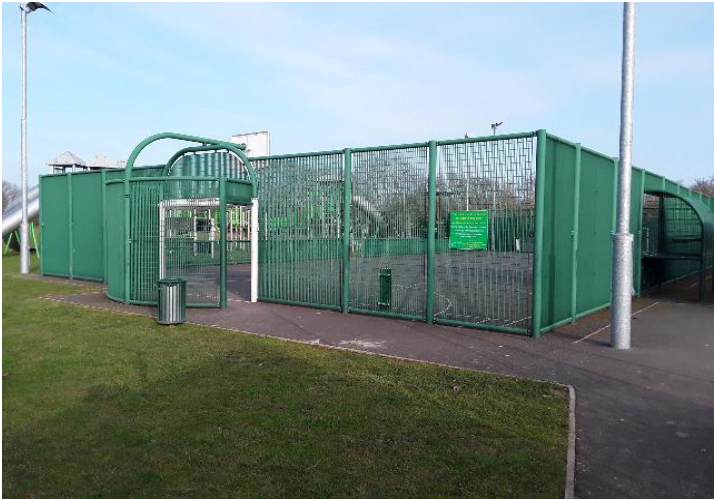
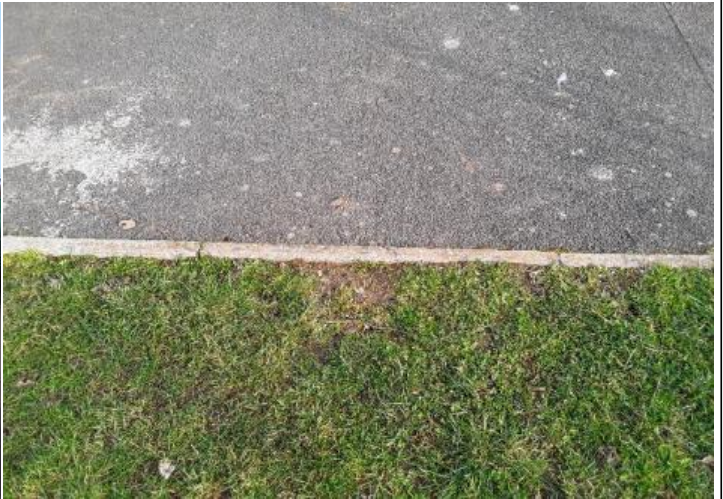
i 8 - Low Risk (Finding 2)

Finding: There are trip hazards at the edges of the surface **Action:** Reinstate surrounding surface levels to remove the trip points

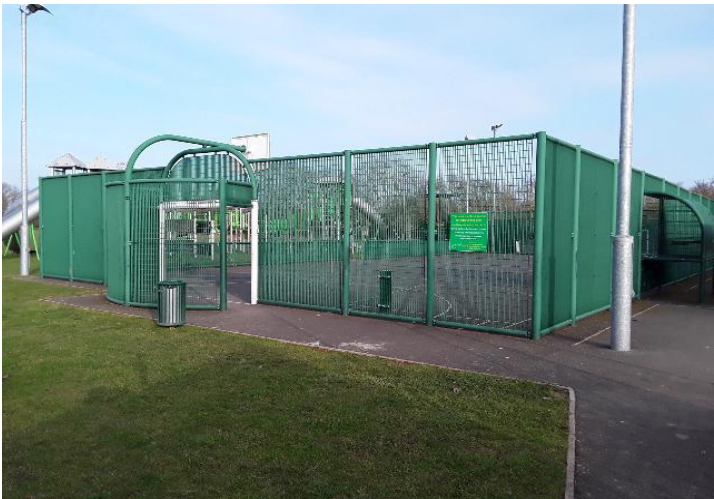
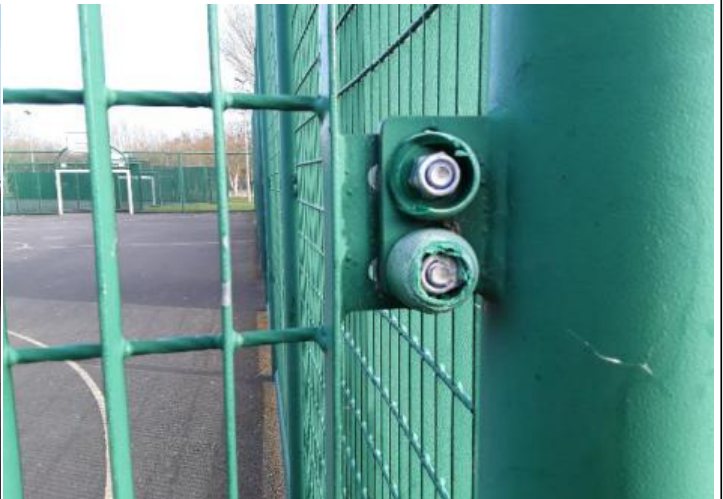
i 4 - Very Low Risk (Finding 3)

Finding: There is/are bolt cap covers missing or damaged on the item **Action:** Replace missing or damaged bolt cap covers

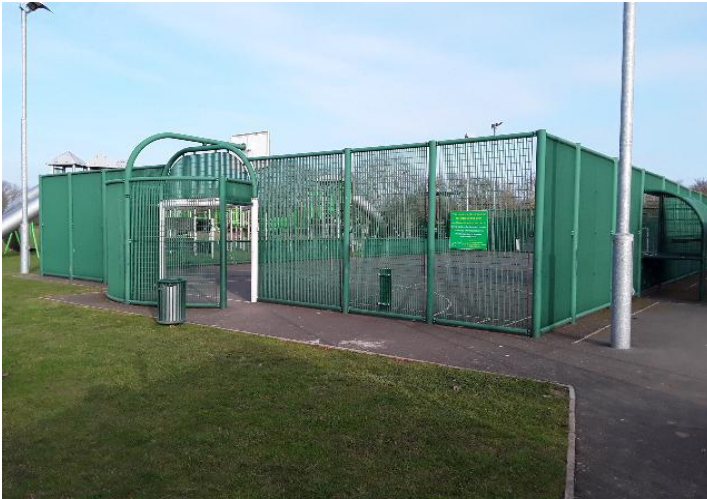
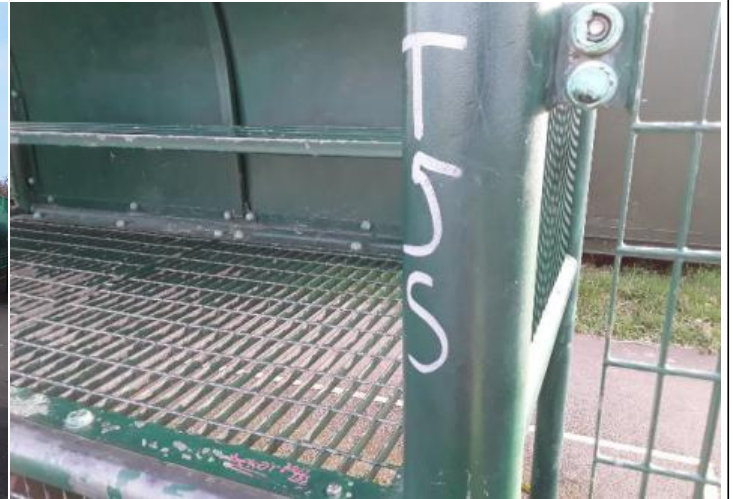
i 2 - Very Low Risk (Finding 4)

Finding: There is some graffiti present

Action: Remove the graffiti

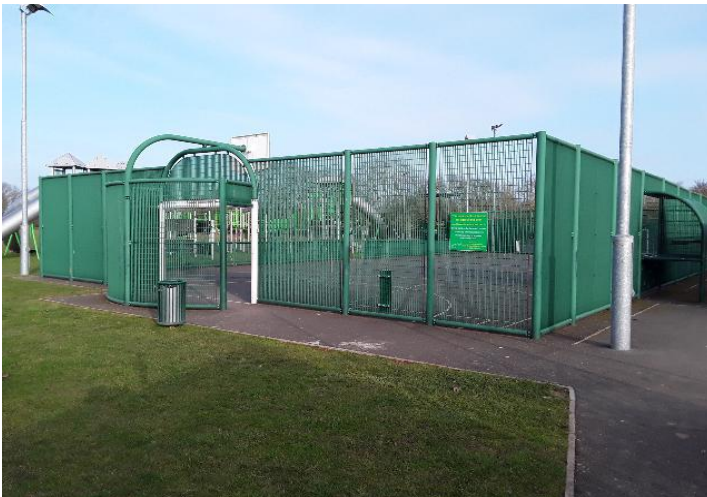
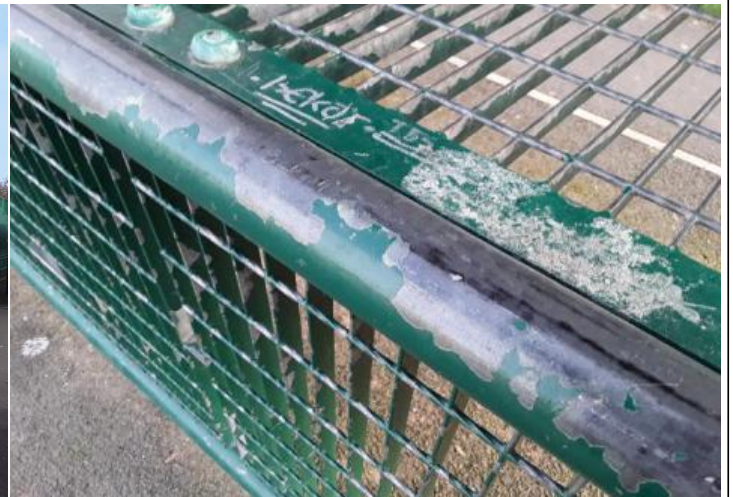
i 6 - Low Risk (Finding 5)

Finding: The paint is flaking off the metalwork

Action: Rub down and re-paint

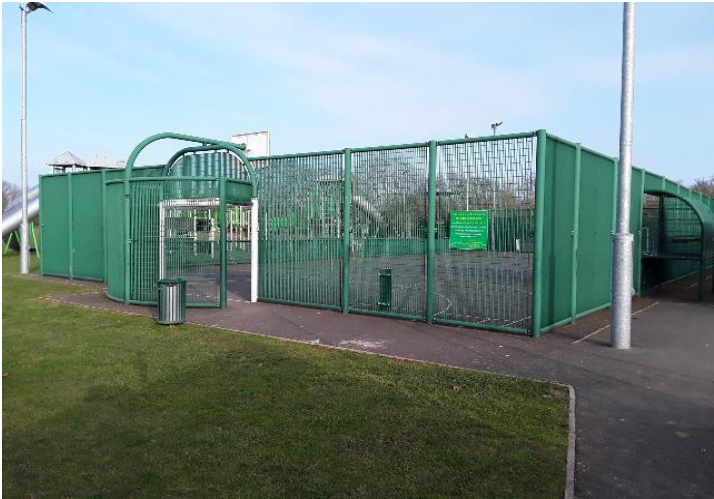
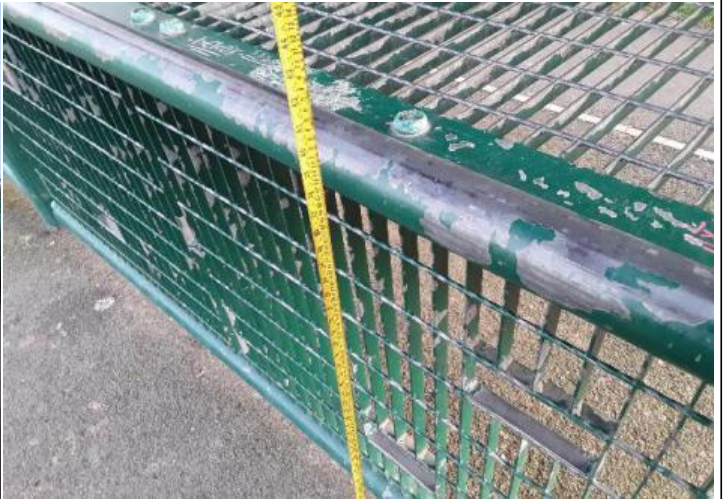
i 8 - Low Risk (Finding 6)

Finding: There are falls in excess of 1.0m from the dug out onto the tarmac surface below **Action:** Monitor use

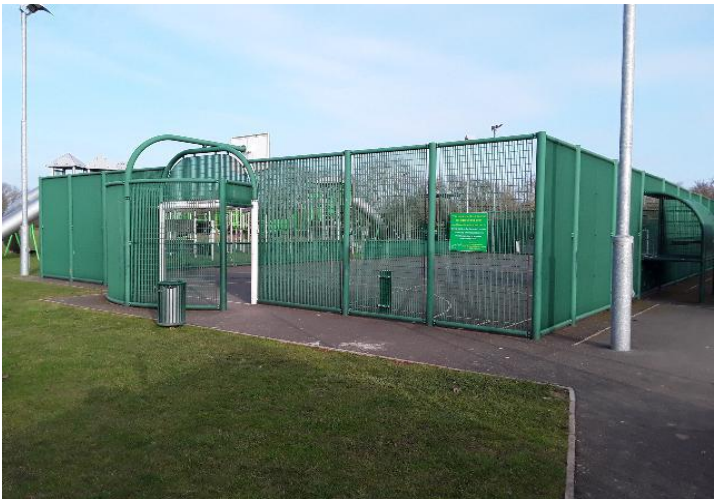
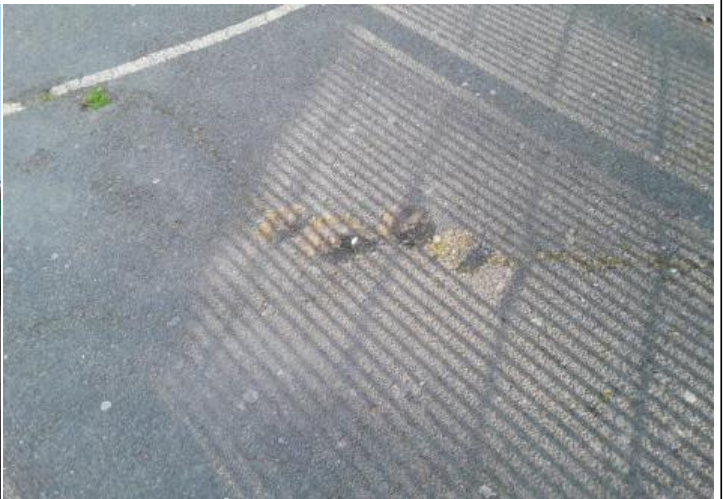
i 8 - Low Risk (Finding 7)

Finding: The tarmac surface has been damaged **Action:** Repair the damaged areas of tarmac to provide a uniform surface

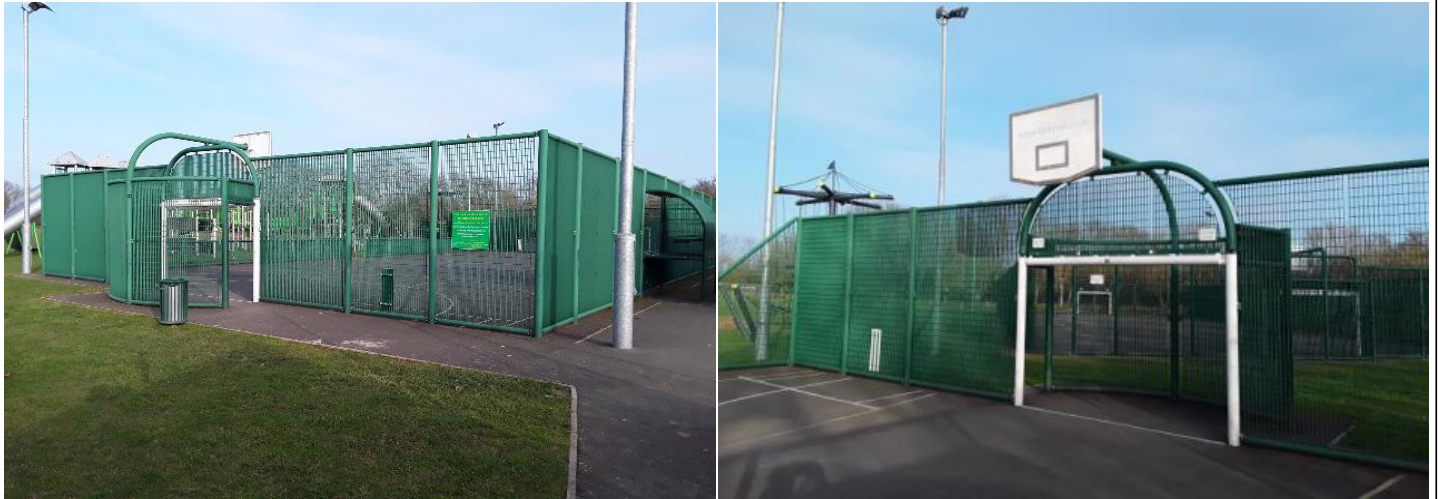
i 4 - Very Low Risk (Finding 8)

Finding: The basketball hoops have been removed

Action: Consider replacing the missing components
