the **play** inspection company

Annual Inspection

Creech St Michael MUGA

Inspection Ref: 1990886

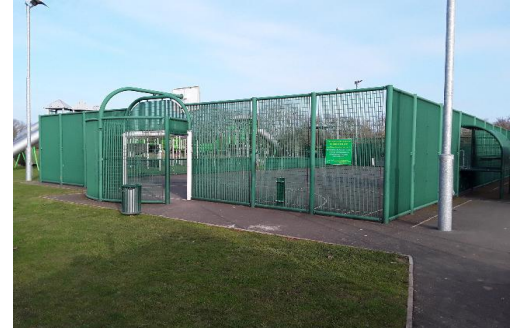
Item: Multi Use Games Area (MUGA)
Manufacturer: Lightmain Engineering
Surface Type: Bitmac
Item Quantity: 1
Equipment Compliance: No
Surface Area Compliance: N/A

Total Findings: 8
